Re: Notice of Violation
Compliance Evaluation Inspection
MNR 000 027 508

COMPLIANCE EVALUATION INSPECTION REPORT

SITE NAME: Graco, Inc.

DATE OF INSPECTION: July 30, 2014

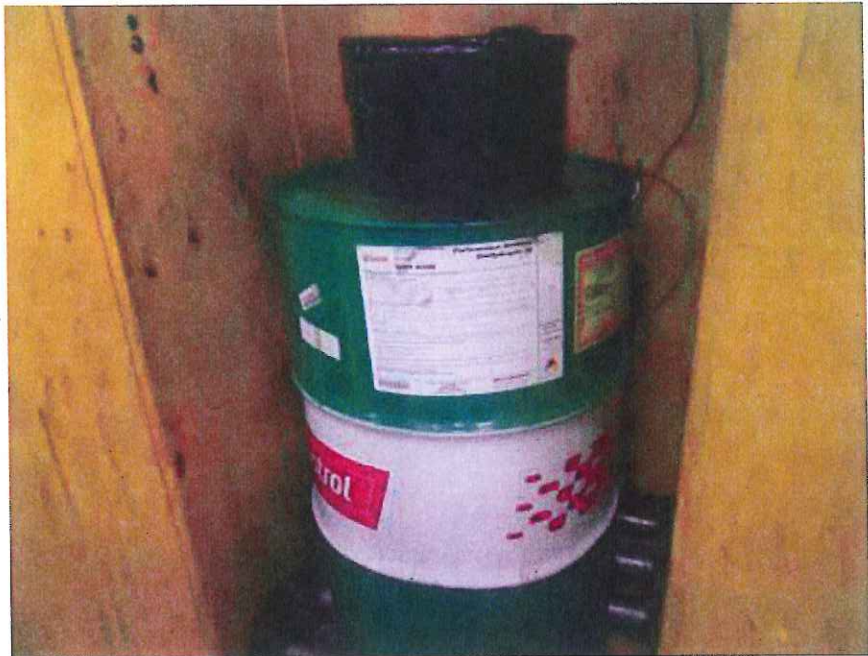
Disk Number 1
Photo Number 4
Photo Filename DSCN0725.JPG
Date/Time 7/30/2014
9:53:00 AM
Photographer Jamie Paulin

SAA container of hazardous waste.
Phosphoric Acid.

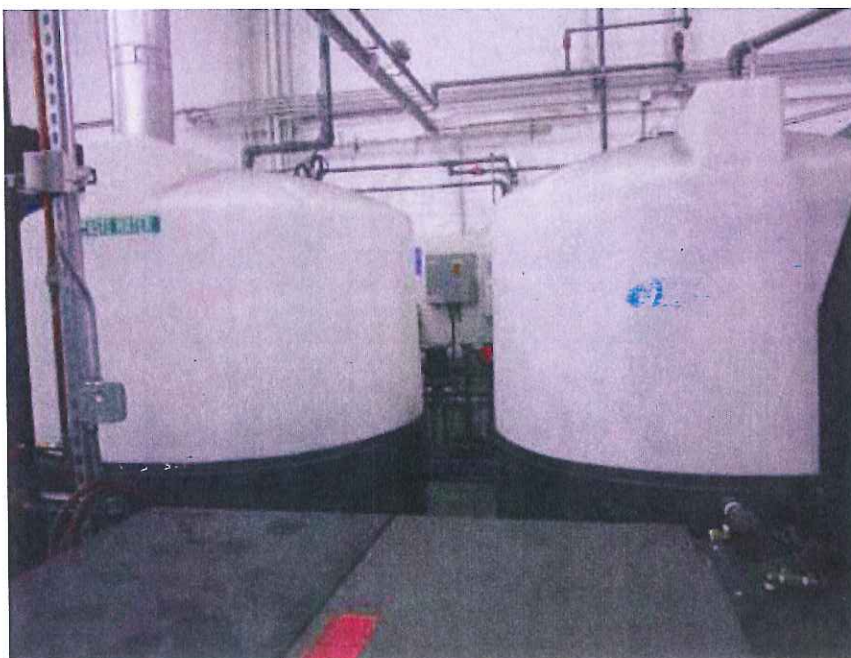
Non-hazardous mop water collection tanks and treatment system.

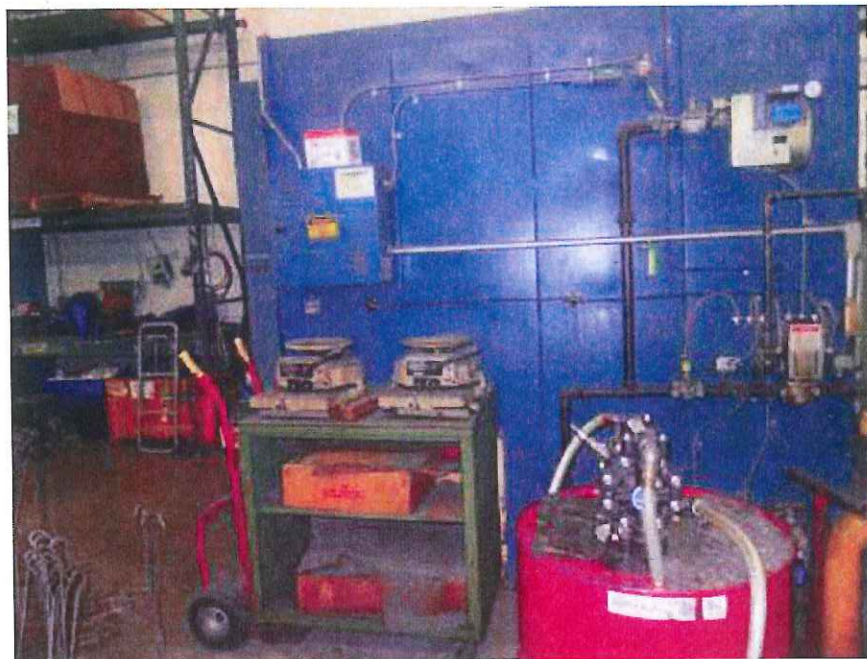
Disk Number 1
Photo Number 14
Photo Filename DSCN0735.JPG
Date/Time 7/30/2014
10:19:00 AM
Photographer Jamie Paulin

Non-hazardous metal booth coating.

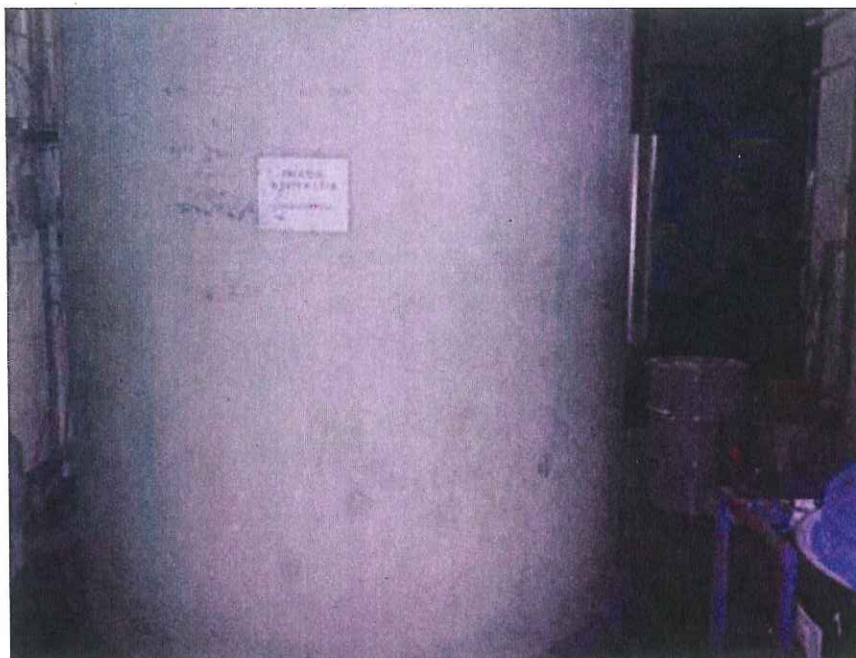
Disk Number 1
Photo Number 16
Photo Filename DSCN0737.JPG
Date/Time 7/30/2014
10:29:00 AM
Photographer Jamie Paulin

Non-hazardous waste paint storage.

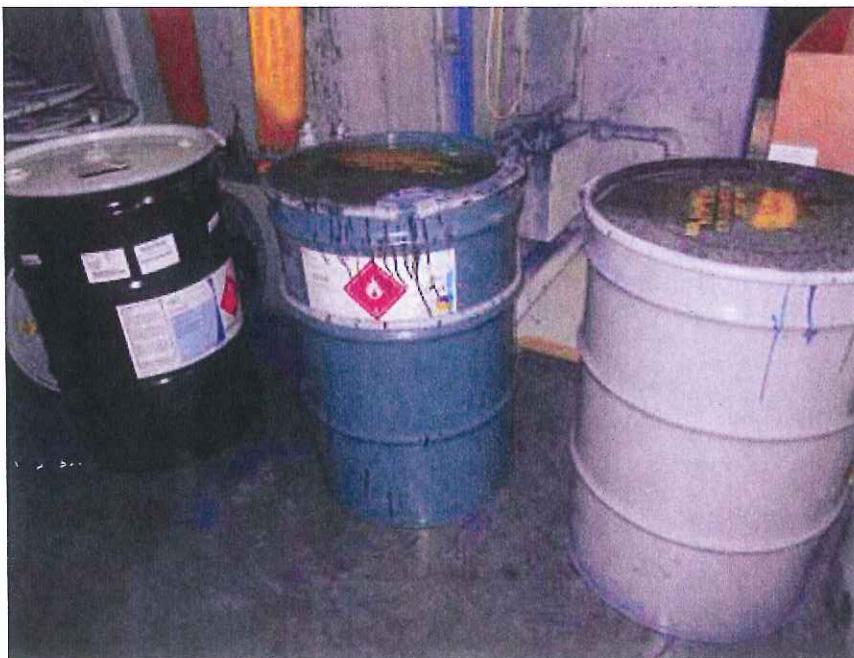
- Additionally, non-hazardous waste paint was being stored in 55-gallon containers. *See*, photograph 16.
- Graco was storing oily debris in open cubic yard metal bins. OSI cleans the area and removes the debris twice per year, according to Mr. Soderquist. *See*, photograph 17.

Oily debris storage. OSI cleans area and removes debris twice per year.

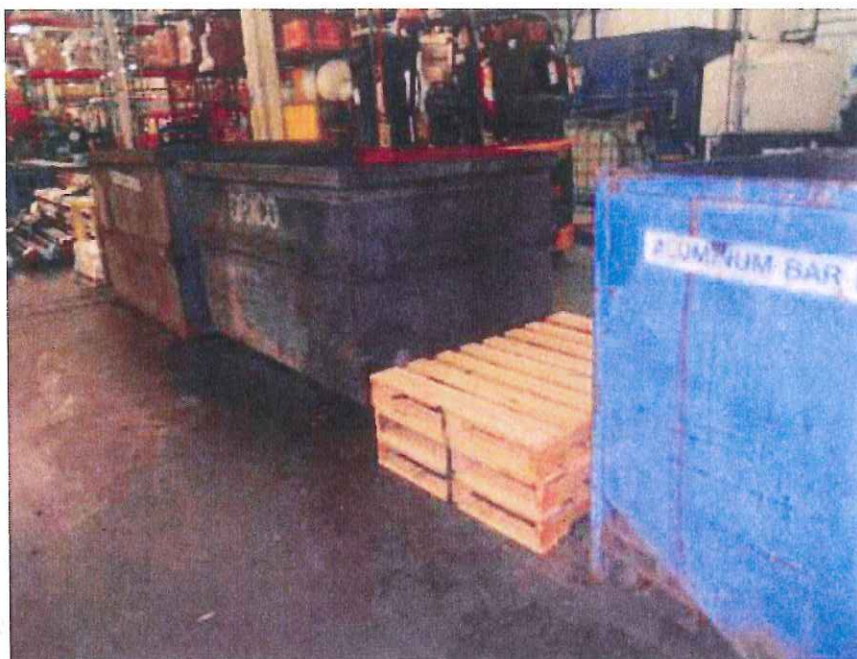
Disk Number 1
Photo Number 18
Photo Filename DSCN0739.JPG
Date/Time 7/30/2014
10:36:00 AM
Photographer Jamie Paulin

Scrap metal storage. Allied Hastings and Alliance steel receive the scrap.

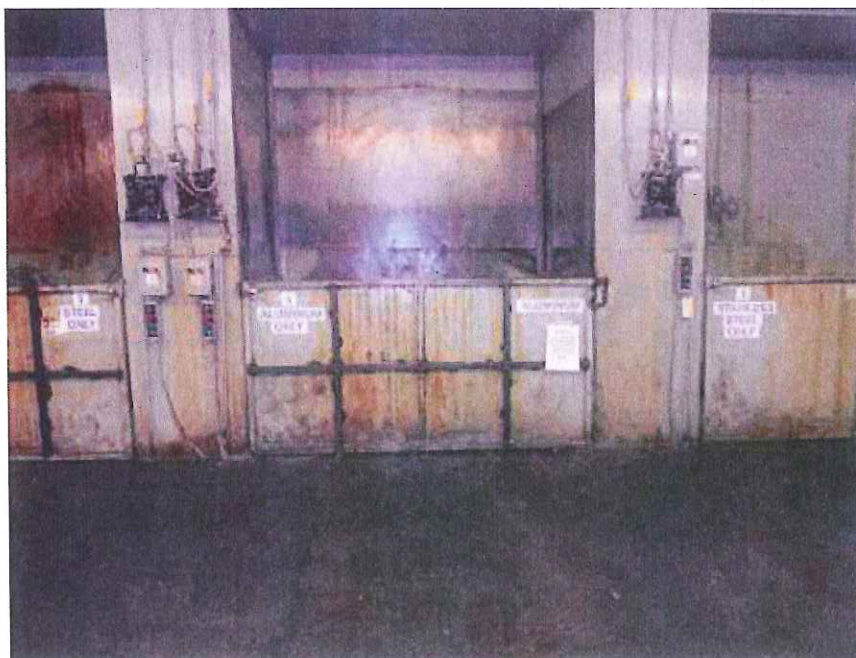
- Near the oily debris storage, Graco was storing scrap metal in bins. They were also operating an oil collection system within the bins and pumping out any oil that was collected. Then Allied Hastings and/or Alliance Steel receive the scrap. *See*, photographs 18, 19 and 20.

Collection of any oil from scrap metal from containers prior to being shipped off-site.

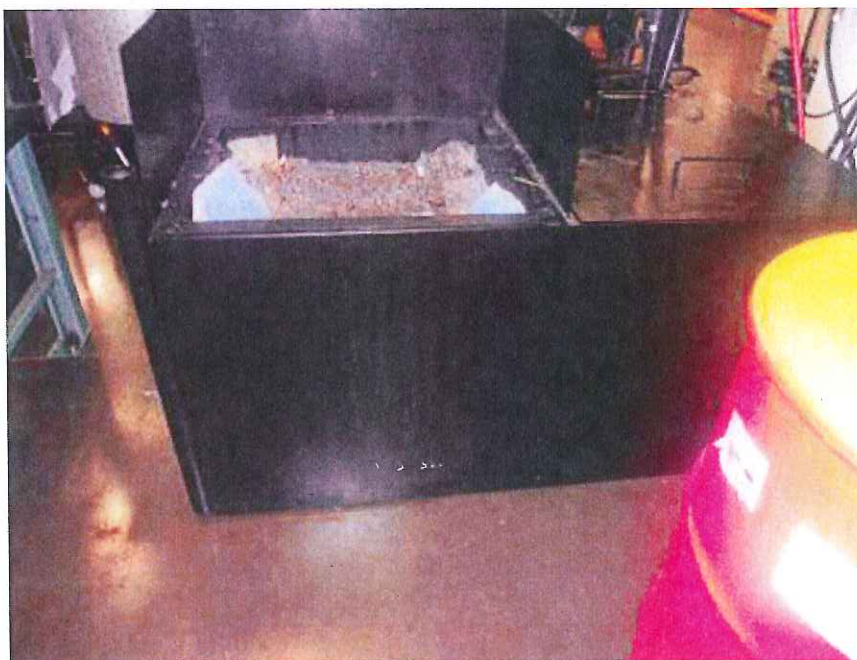
Non-hazardous parts washer.

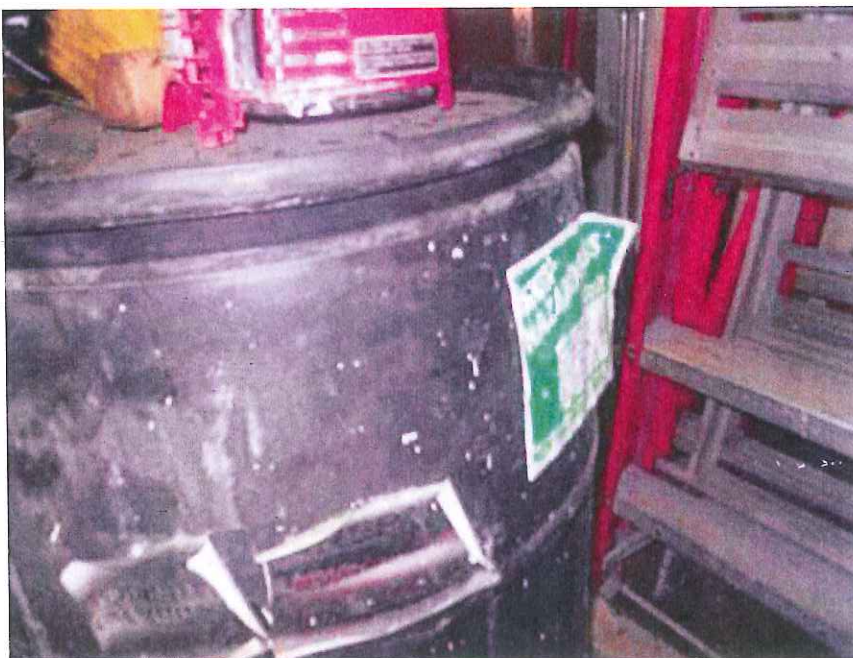
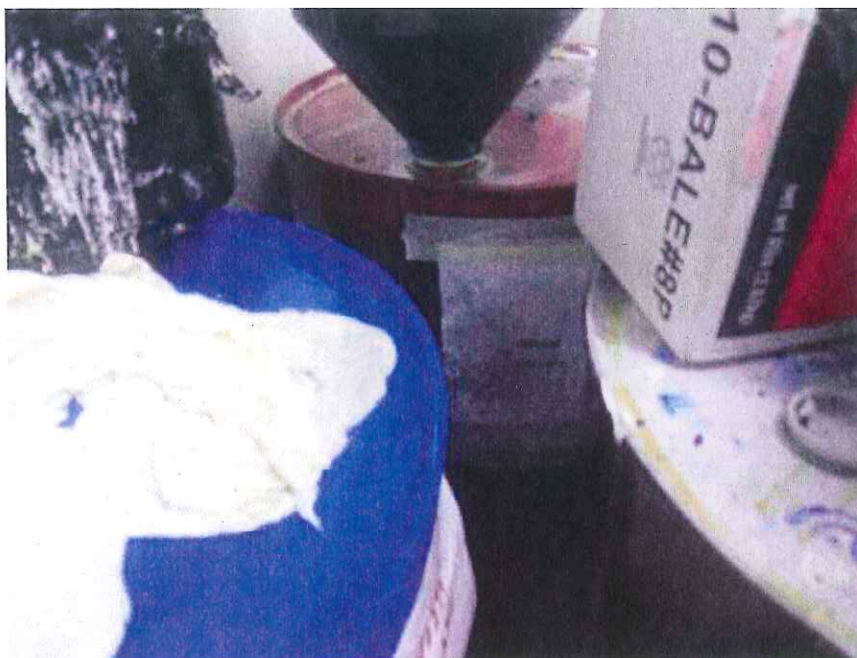
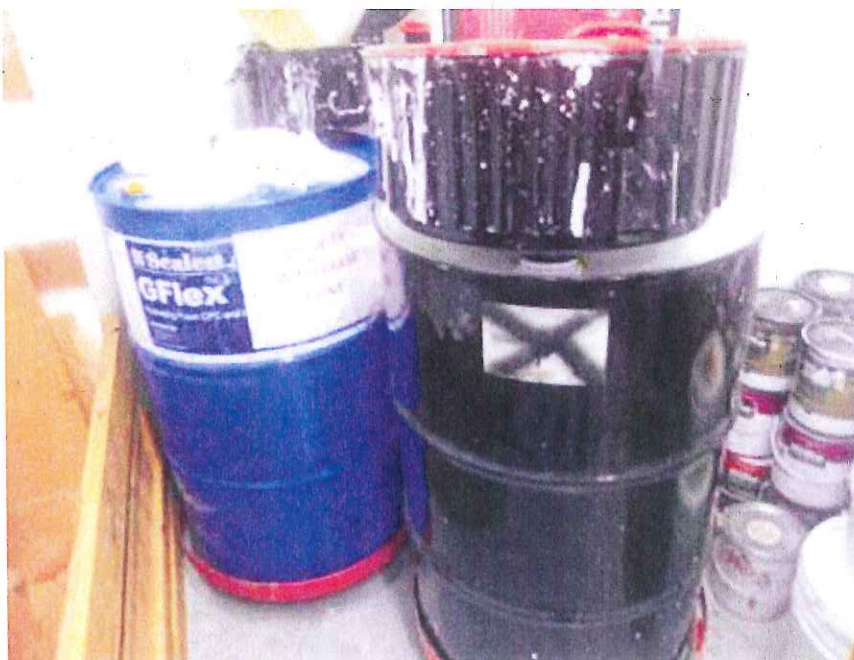
At the time of the inspection, Graco was storing more than 55 gallons of the hazardous waste solvent in various sized containers located in the waste solvent collection area.

At the time of the inspection, Graco was storing hazardous waste solvent in various sized containers, located in the waste solvent collection area, without being marked with the words, "Hazardous Waste," or with words identifying the contents of the containers.

At the time of the inspection, Graco was storing greater than 55 gallons of hazardous waste solvent in various sized containers, located in the waste solvent collection area. The containers were not marked with the date of accumulation and had not been transferred to a hazardous waste storage area within three days.

- Waste solvents and waste paints were being stored in an area that was designated as an SAA. However, more than 55 gallons were being stored in this area of the same waste stream. The majority of the containers were not marked with an accumulation start date or with the words, "Hazardous Waste." The containers were being stored in this area for extended periods of time and being removed from the area for disposal approximately four times per year. *See*, photographs 25 through 28.

Waste solvent collection area. Area is designated as an SAA however more than 55 gallons were being stored in this area.

At this time, EPA is not requiring Graco to apply for a Minnesota hazardous waste storage permit so long as it immediately establishes compliance with the conditions for a permit exemption outlined in paragraphs 1 through 3, above.

I did state that Graco should revise the Contingency Plan to exclude the UST. I also said that, for the area in the R&D laboratory to be considered an SAA, Graco would need to store up to 55 gallons of hazardous waste, or they could consider that area to be a hazardous waste storage area.

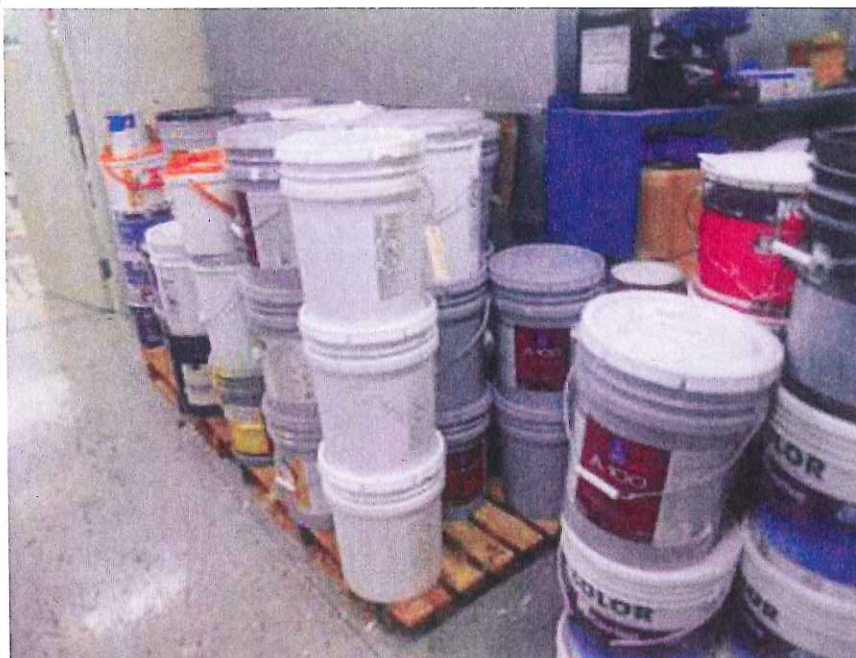
Disk Number 1
Photo Number 28
Photo Filename DSCN0749.JPG
Date/Time 7/30/2014
11:31:00 AM
Photographer Jamie Paulin

SAA hazardous waste container storage.
